Case Study

Solving Erosion in Dump Valves

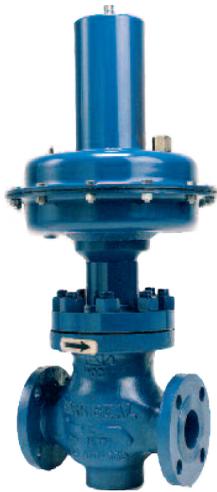
Series 2720 Control Valve

The Norriseal Series 2720 control valve properly configured to their sand application with the correct trim material, correct flow direction, adjustable actuator, and had a lower cost of ownership even though the initial 2720 cost is higher than the competitor's valve. A Series 4" 2720 control valve was installed at one production site 10 months ago and the valve is still operating with only one trim change ordered by the oil & gas producer during scheduled maintenance. The valve was configured with tungsten carbide trim material overcoming the erosive properties of sand, the flow direction under the plug dispersing the produced fluid over wider area of metal surfaces, and the adjustable spring actuator will allow fine-tuning of the process to minimize the erosive effect. Additionally, the Norriseal 4" valve has a higher flow capacity, which will reduce the pressure drop and flow velocities.

- **Reliability:** Norriseal valve is lasting 10 times or longer than the competitor's valve.
- **Higher Flow Capacity:** 4.0" Norriseal valve Cv value is 211 compared to 71 Cv of the competitor's valve.
- **Durability:** Norriseal valve uses tungsten carbide trim for erosive applications.
- **Cost of Ownership:** Even though the Norriseal valve has a higher initial cost, the overall cost of ownership is lower by: 1. No loss of production; 2. Less valve change outs/repairs with valve life lasting ten times longer; 3. Reduced labor cost with less maintenance.
- **Cost of Repair:** Norriseal valve does not require the cage and guide to be replaced during trim maintenance.
